PARAJET SAFETY ADVISORY BULLETIN

AUGUST 2020 - THROTTLE CABLE RETAINER INSTALLATION

Parajet Maverick, Parajet Zenith and Parajet Evolution 3 paramotors

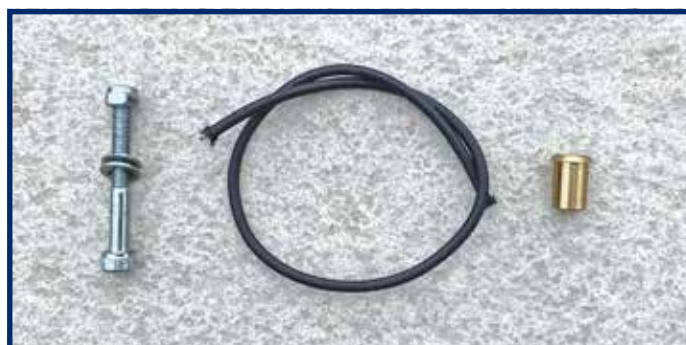
1 Bungee Cord Retaining System Upgrade Kit

The bungee cord retaining system upgrade kit, shown above [Figure 1], should be fitted to all older Parajet models that use the now obsolete Velcro retaining strap following the installation instructions detailed in the corresponding Technical Bulletin available to download at <https://parajet.com/existing-pilots/user-manuals/>

Pilots of paramotors fitted with the now obsolete Velcro retaining strap should contact Parajet to request a bungee cord retaining system upgrade kit which will be sent out free of charge.
